Weathered AF72 CILL DETAIL

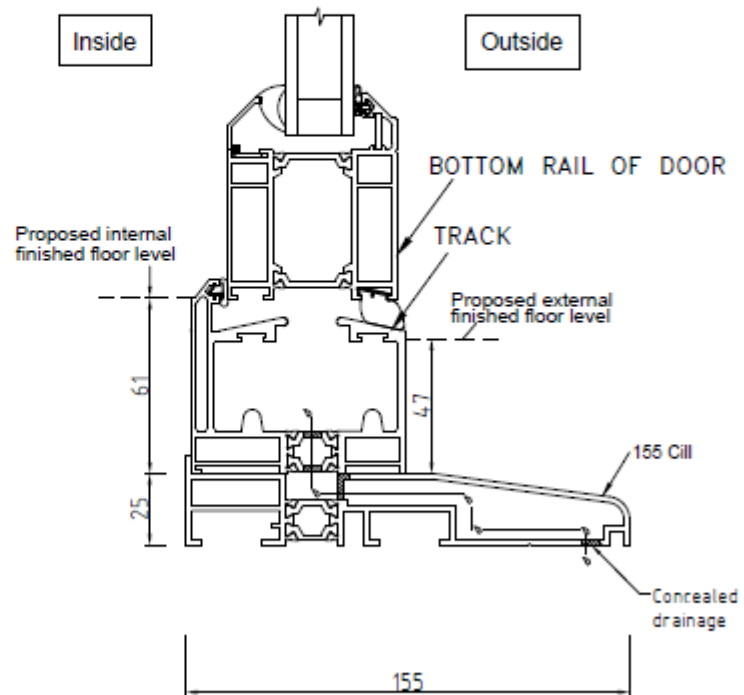
B - Rebated Threshold Detail with concealed drainage
